Appendix E

Photograph Log

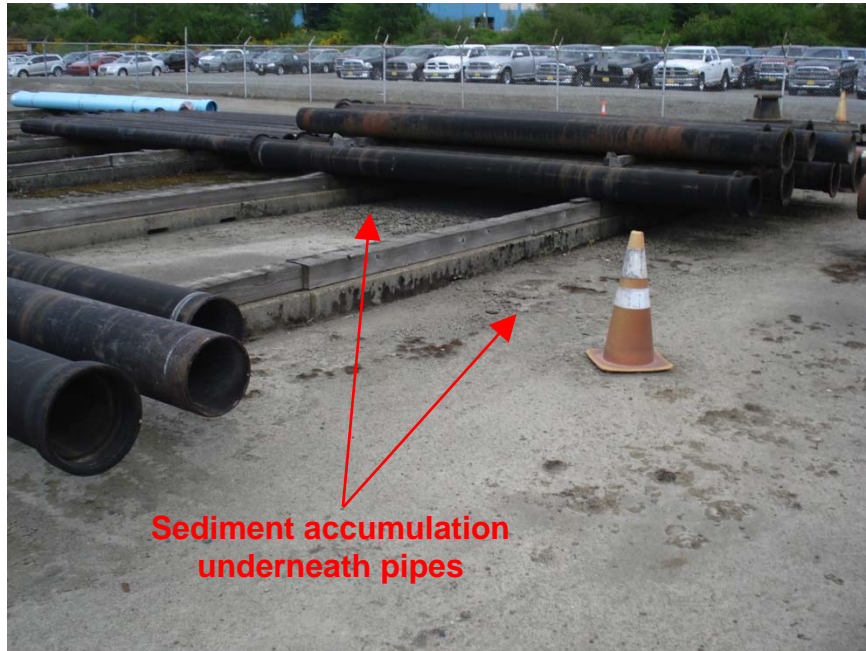
Photograph 1. Water Distribution Operations Center – View of sediment accumulation in the pipe storage area.

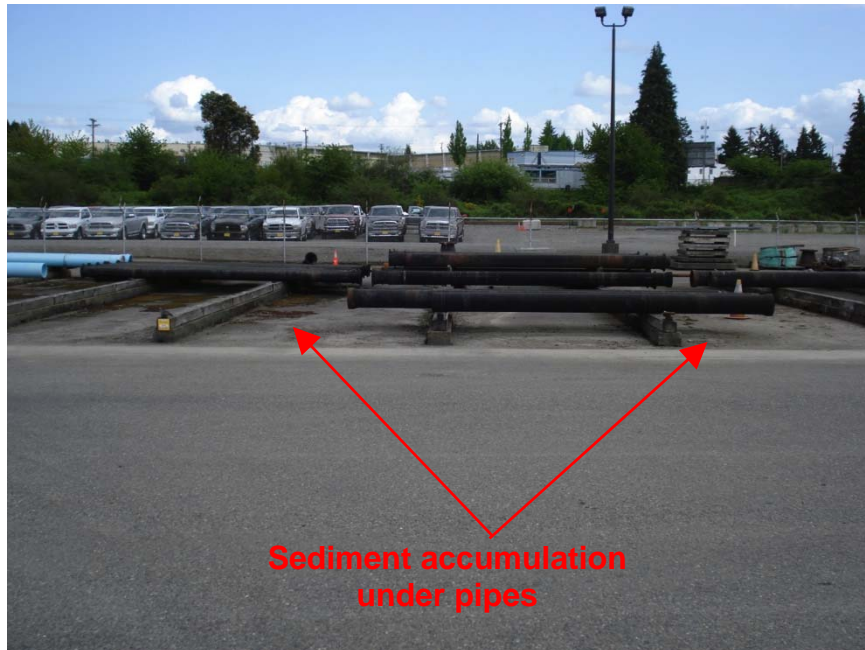
Photograph 2. Water Distribution Operations Center – View of sediment accumulation in the pipe storage area.

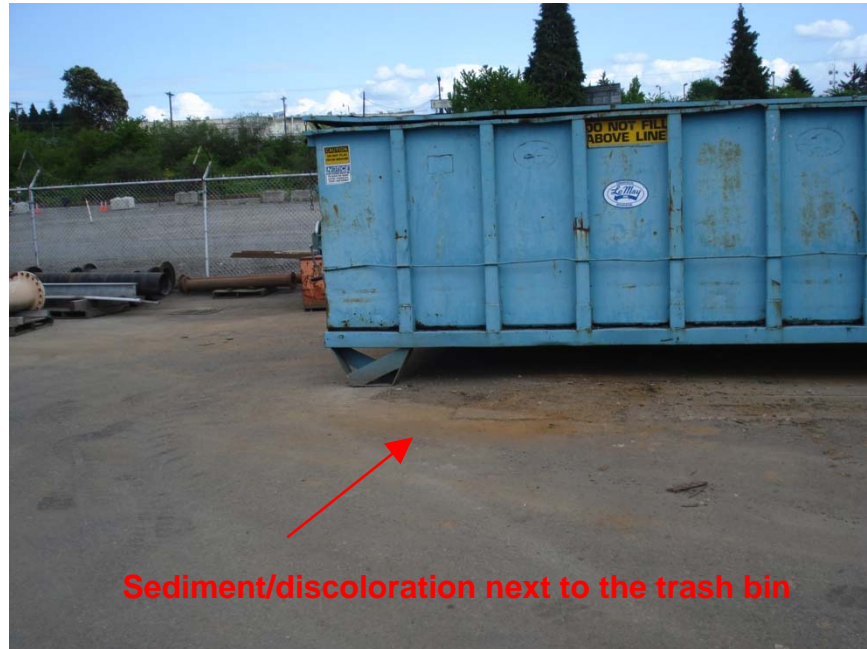
Photograph 3. Water Distribution Operations Center – View of sediment accumulation near the trash bin on the south side of the facility.

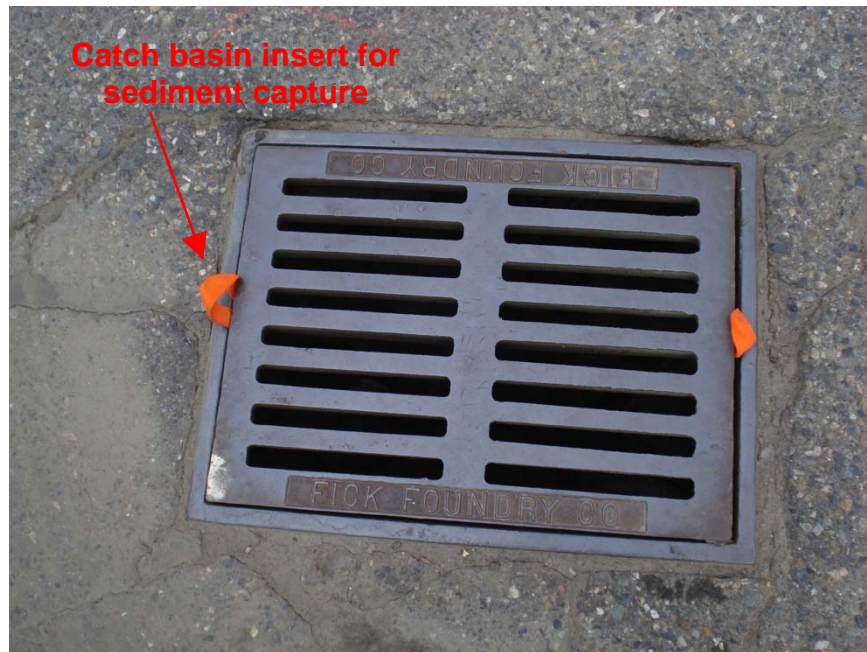
Photograph 4. Water Distribution Operations Center – View of drop inlet with tabs from filter fabric installed to capture sediment.

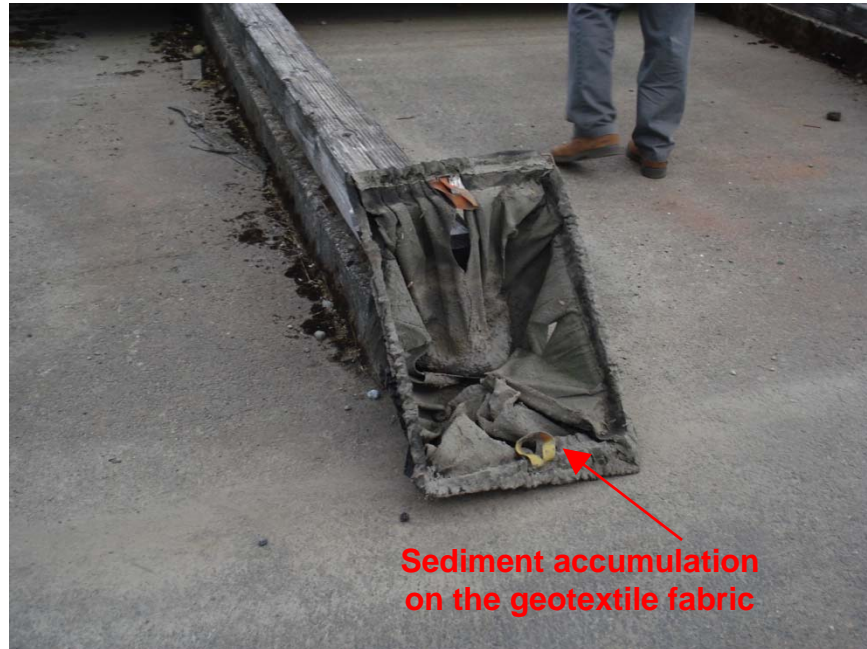
Photograph 5. Water Distribution Operations Center – View of catch basin insert removed. Note the sediment accumulation on the geotextile fabric.

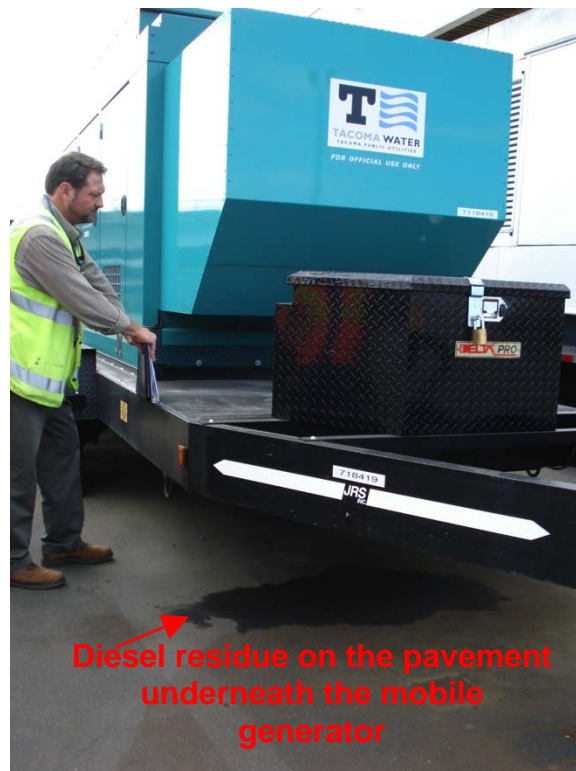
Photograph 6. Water Distribution Operations Center – View of diesel residue on the asphalt pavement leading from the mobile generator.

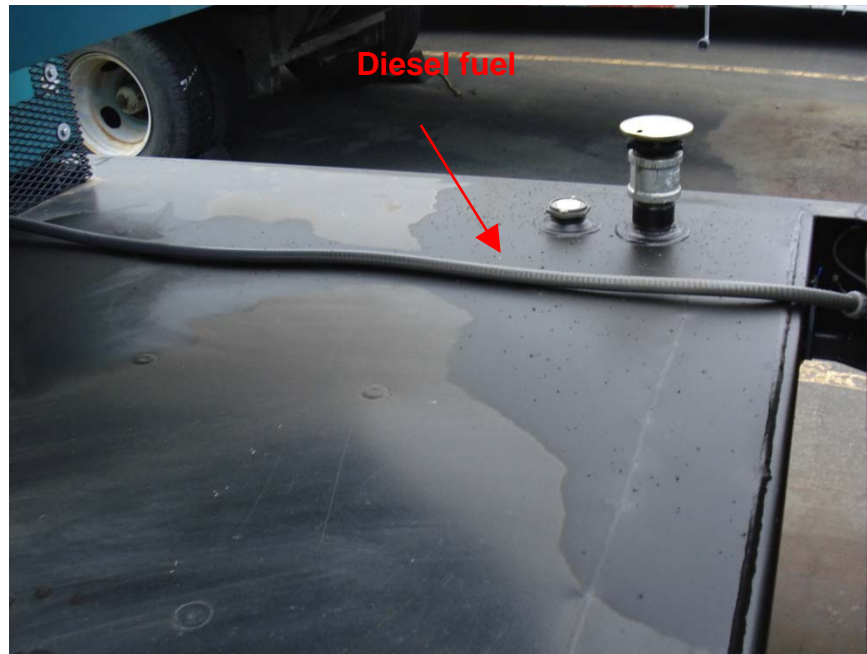
Photograph 7. Water Distribution Operations Center – View of diesel fuel spilled near the fueling nozzle on the mobile generator shown in Photograph 6.

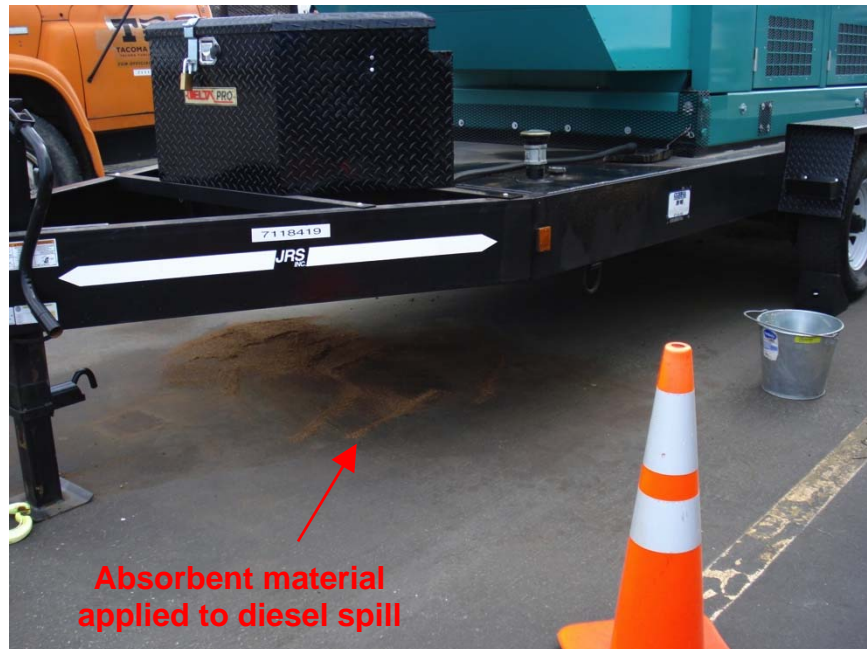
Photograph 8. Water Distribution Operations Center – View of material applied on the pavement to absorb diesel fuel from the mobile generator shown in Photographs 6 and 7.

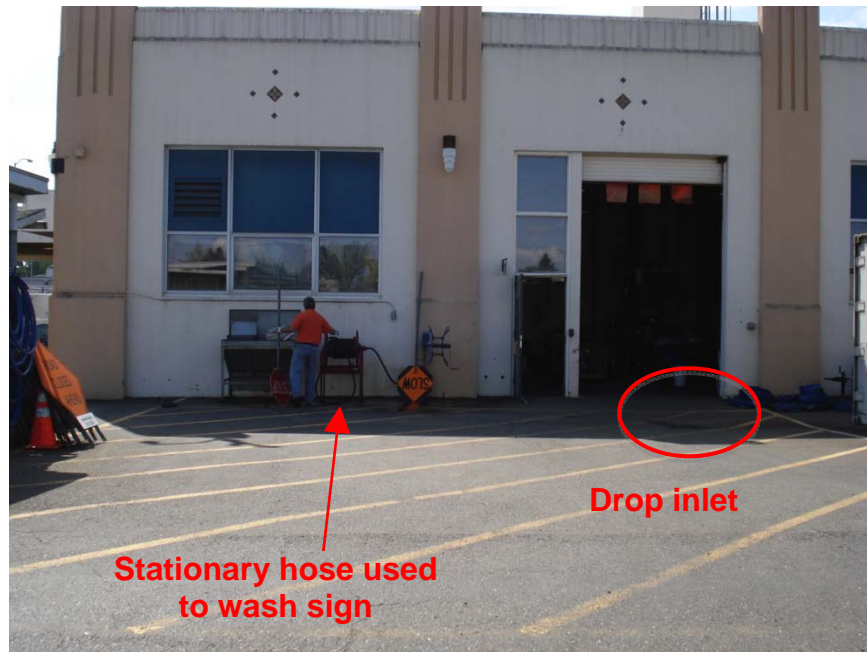
Photograph 9. Water Distribution Operations Center – View of staff member washing a sign on the east side of the Fleet Services Shop. Note the proximity to the drop inlet.

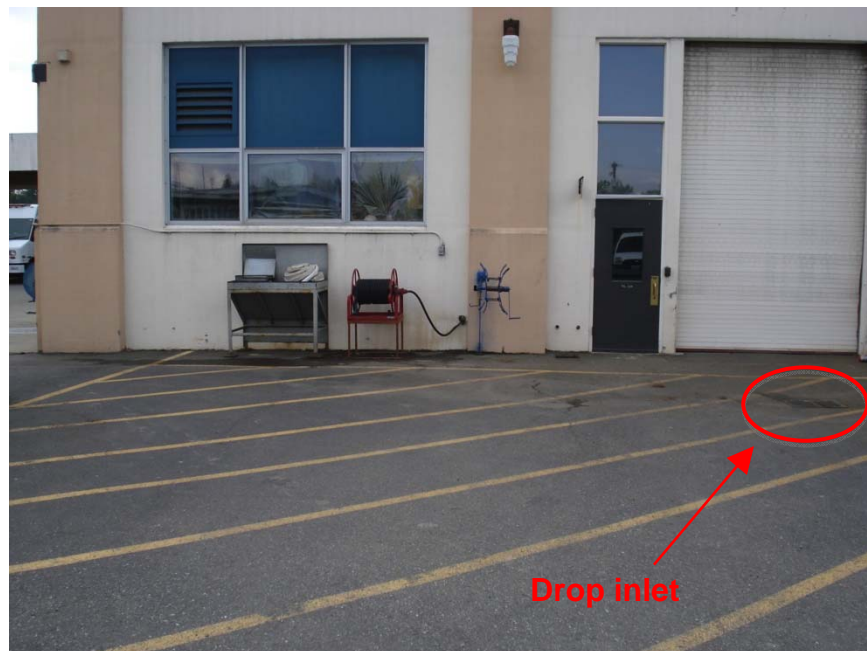
Photograph 10. Water Distribution Operations Center – Close-up view of area shown in Photograph 9.

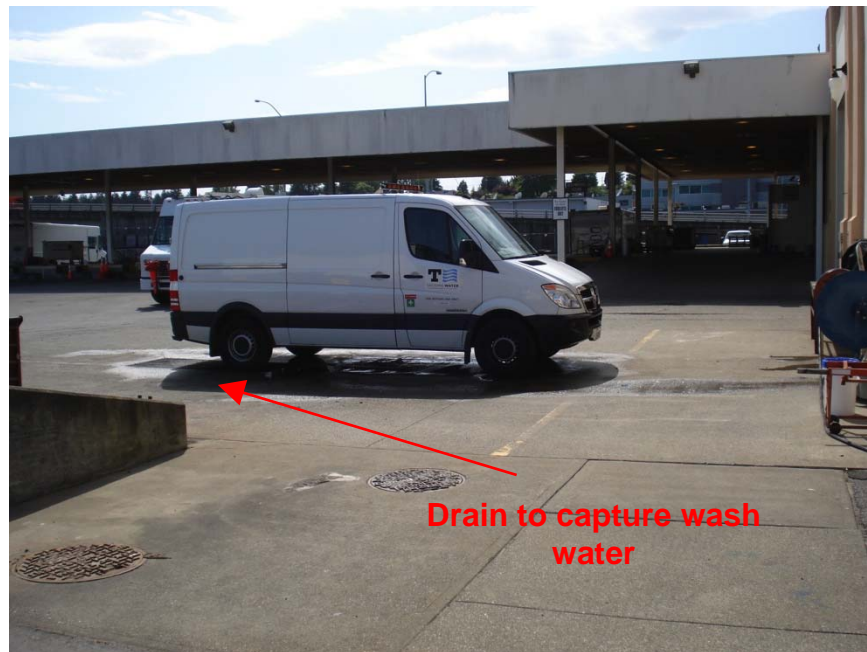
Photograph 11. Water Distribution Operations Center – View of wash pad on the southwest side of the Fleet Services Shop. Note wash pad is not within a covered or contained area.

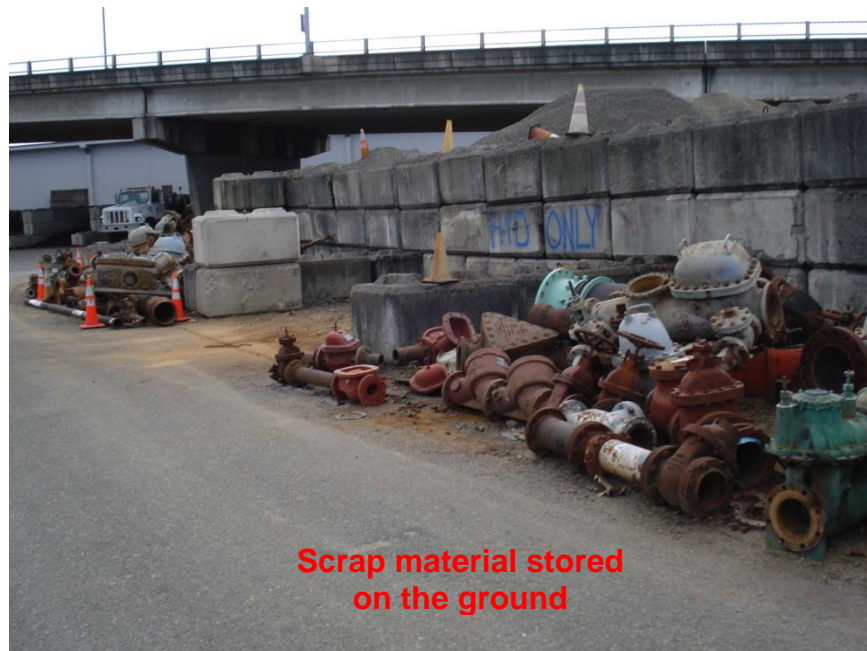
Photograph 12. Water Distribution Operations Center – View of scrap material stored directly on the asphalt pavement in the south side of the facility. Note rust on material.

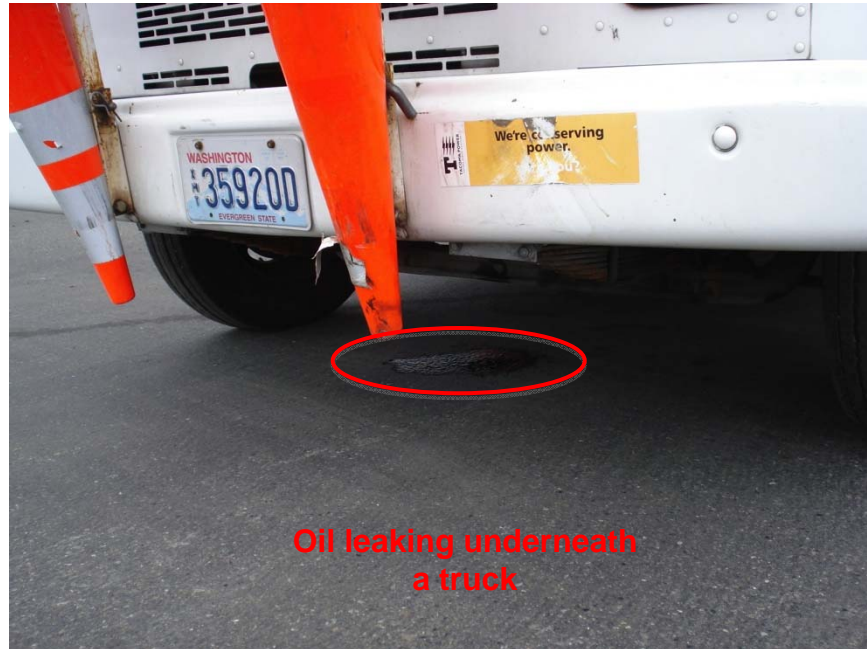
Photograph 13. Water Distribution Operations Center – View of an active oil leak underneath a truck parked near the loading docks.

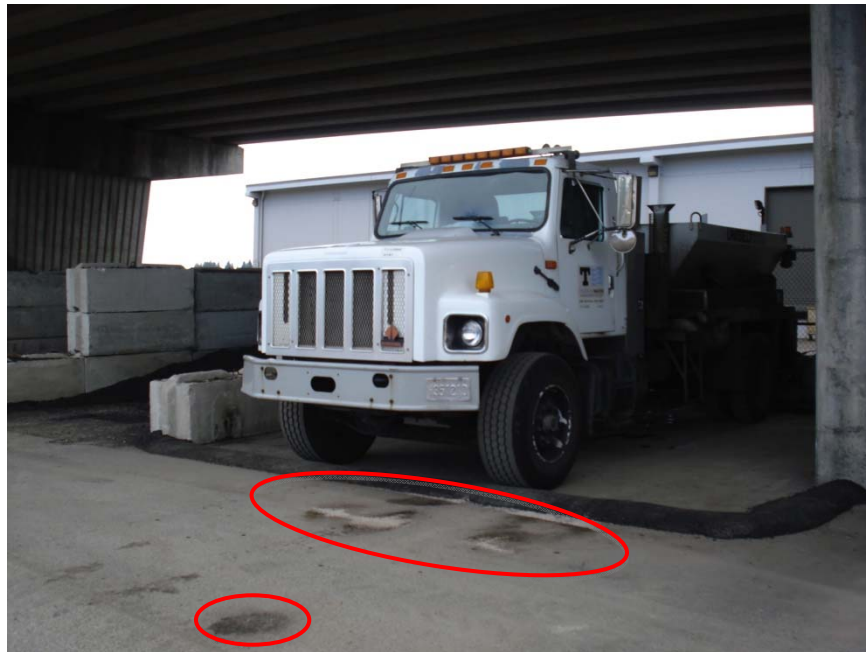
Photograph 14. Water Distribution Operations Center – View of oil stains adjacent to parking area for a truck used for temporary patching. Note asphalt berm constructed in parking area.

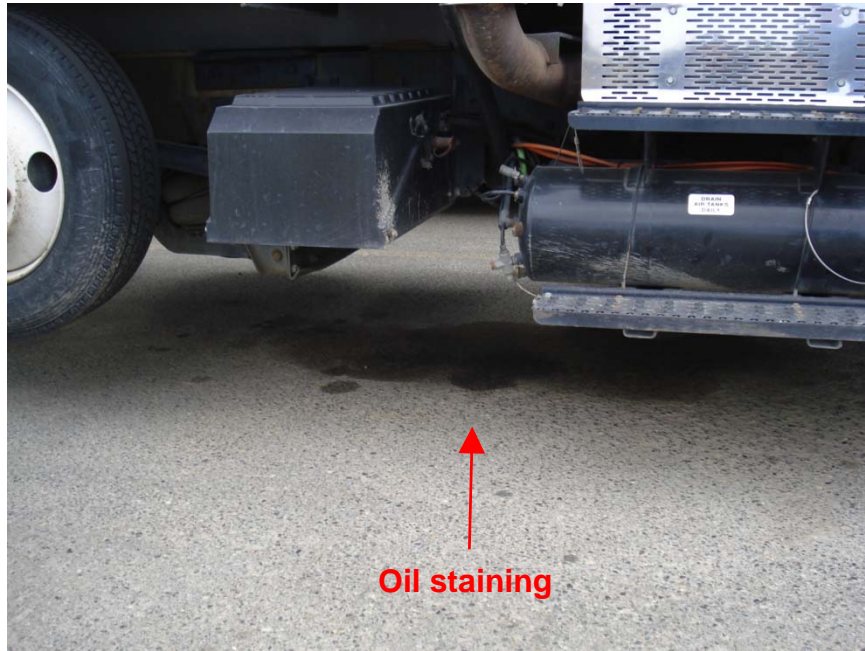
Photograph 15. **Water Distribution Operations Center – View of oil staining in the truck parking area.**

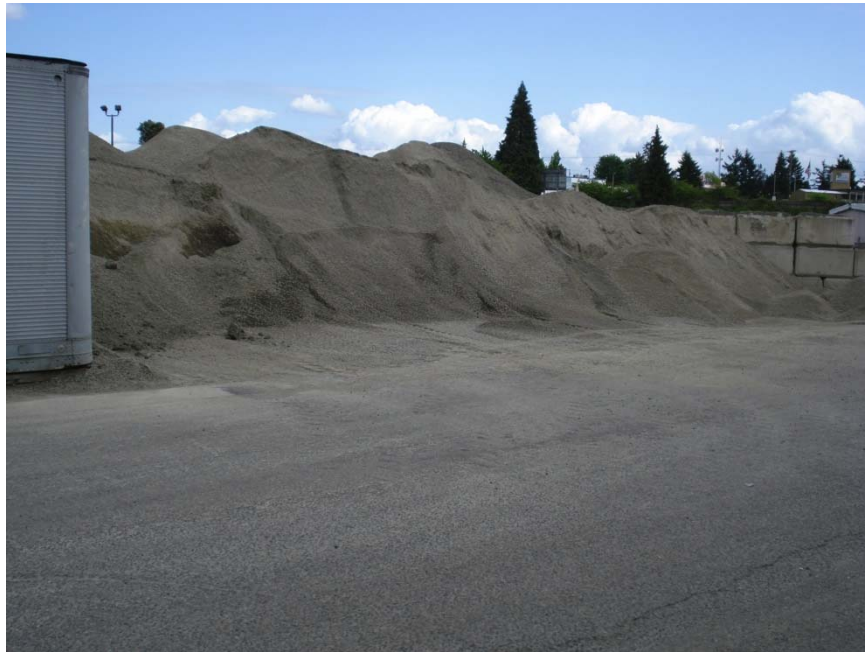
Photograph 16. **Water Distribution Operations Center – View of stockpile area for trench backfill.**

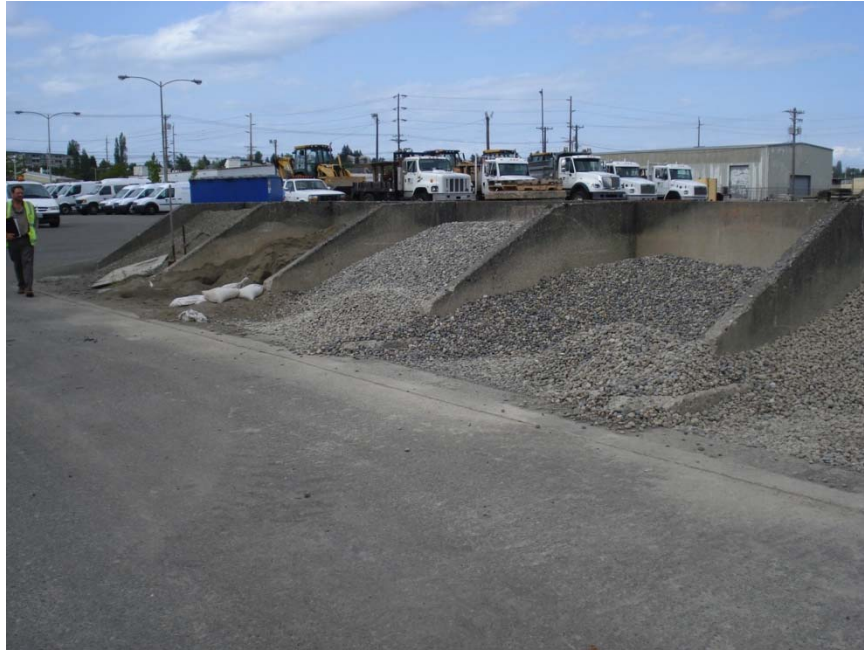
Photograph 17. Water Distribution Operations Center – View of stockpile area for rock, gravel, and sand.

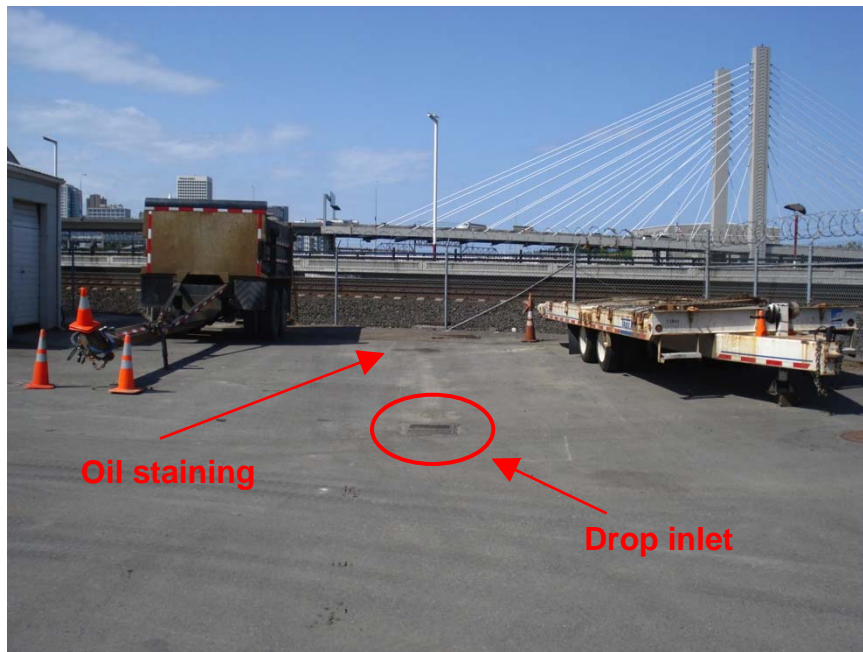
Photograph 18. Dock Street Yard – View of parking area on the north side of the facility. Note oil stains upgradient of storm drain drop inlet.

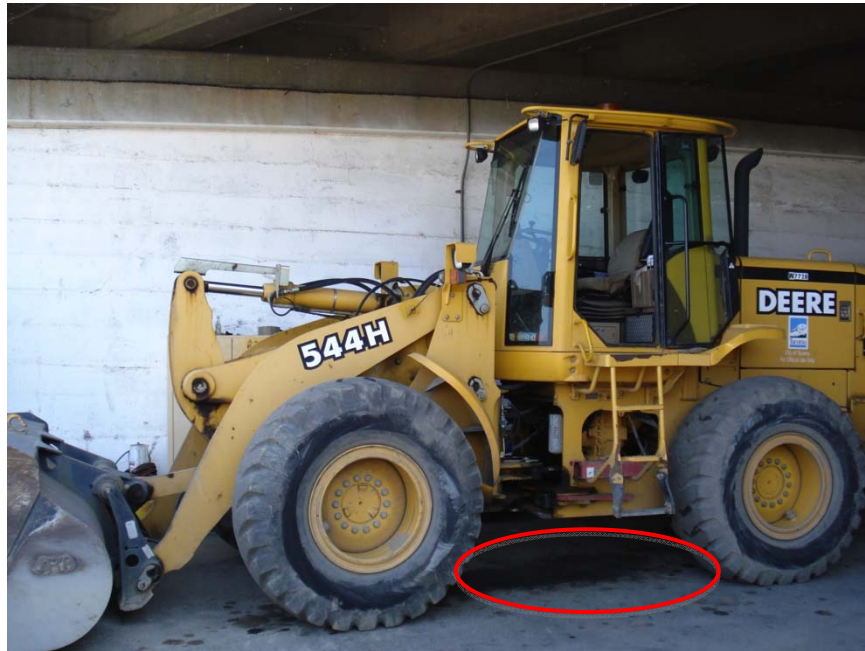
Photograph 19. Dock Street Yard – View of oil staining under heavy equipment parked in a covered area.

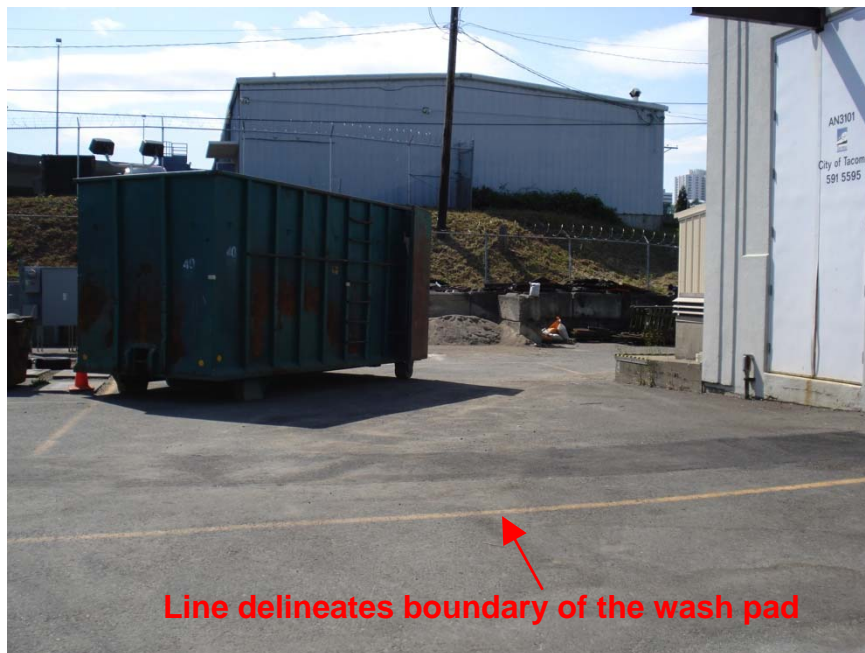
Photograph 20. Dock Street Yard – View of dedicated wash pad in the northwest corner of the facility. Painted line delineates the boundary of the wash pad.

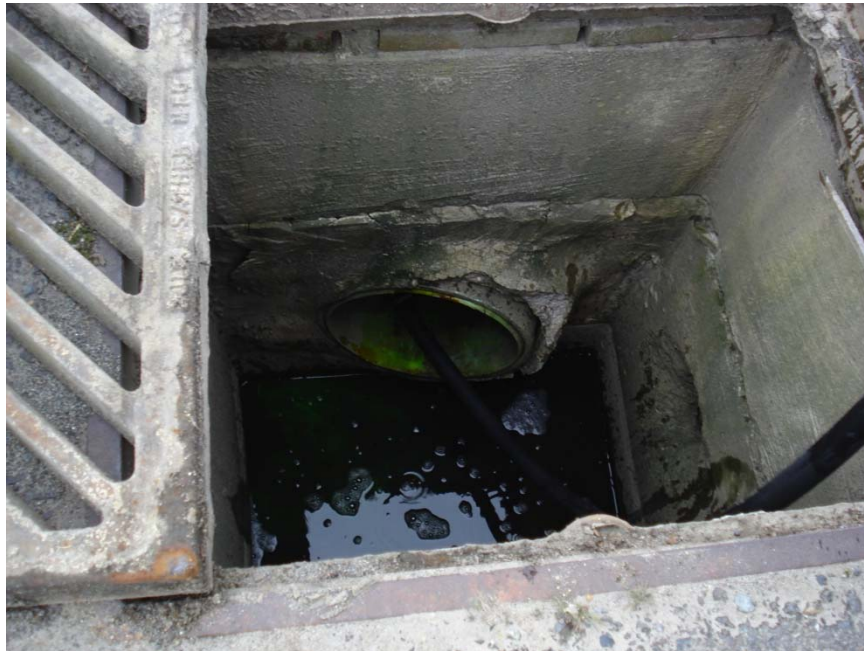
Photograph 21. Dock Street Yard – View inside drop inlet showing green dye in the storm drain pipe.

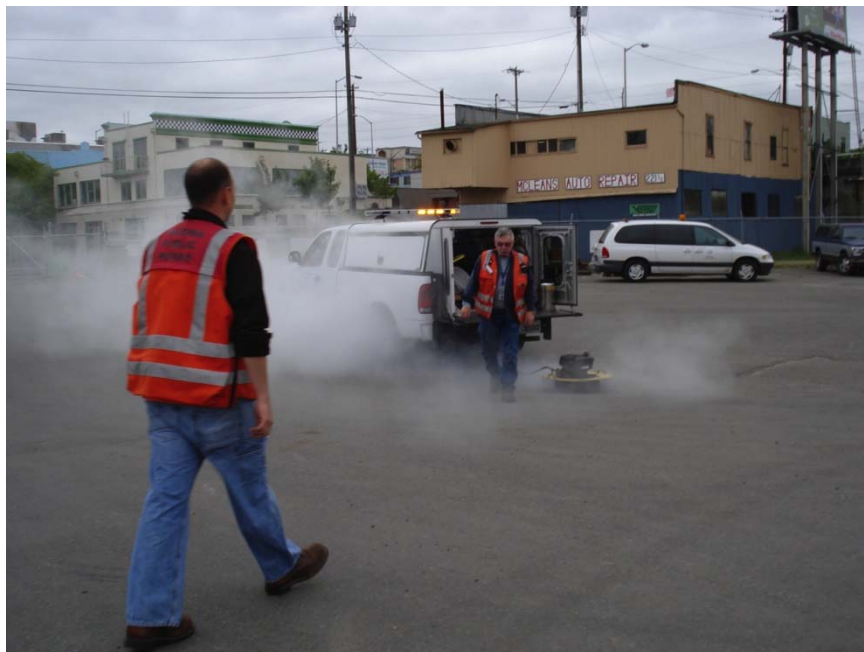
Photograph 22. Dock Street Yard – View of smoke testing to confirm drop inlets that drain to the stormwater drainage system.

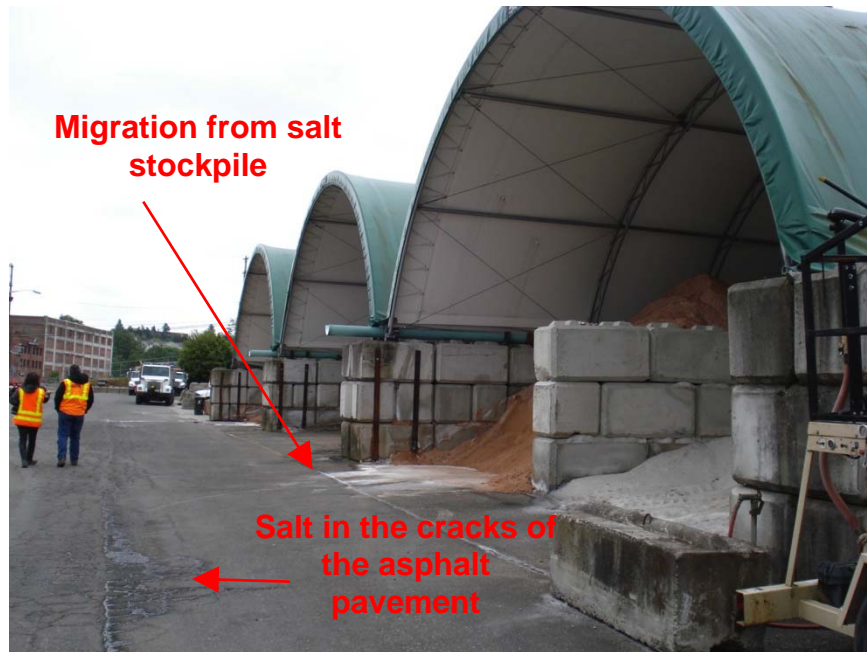
Photograph 23. Upper Yard Storage Garage – View of the area for storing ice slicer, roadway salt, and salt/sand mix. Note white salt residue in the cracks of the asphalt pavement.

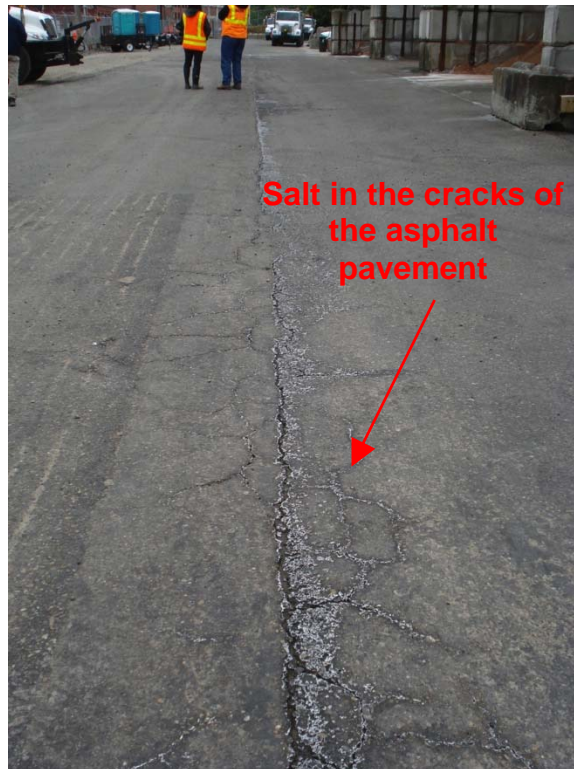
Photograph 24. Upper Yard Storage Garage – View of salt in the cracks of the asphalt pavement.

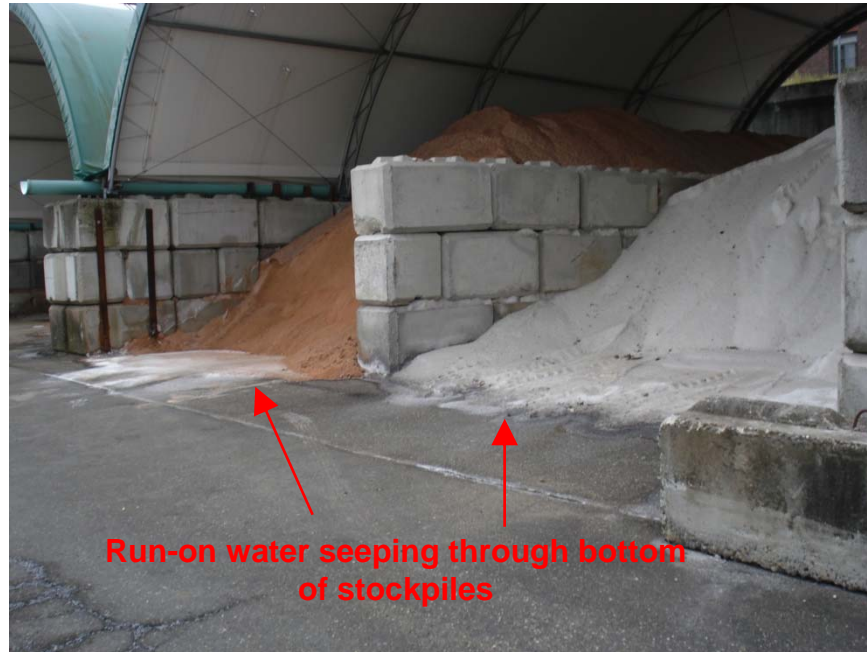
Photograph 25. Upper Yard Storage Garage – View of run-on water seeping through the bottom of ice slicer and roadway salt stockpiles.

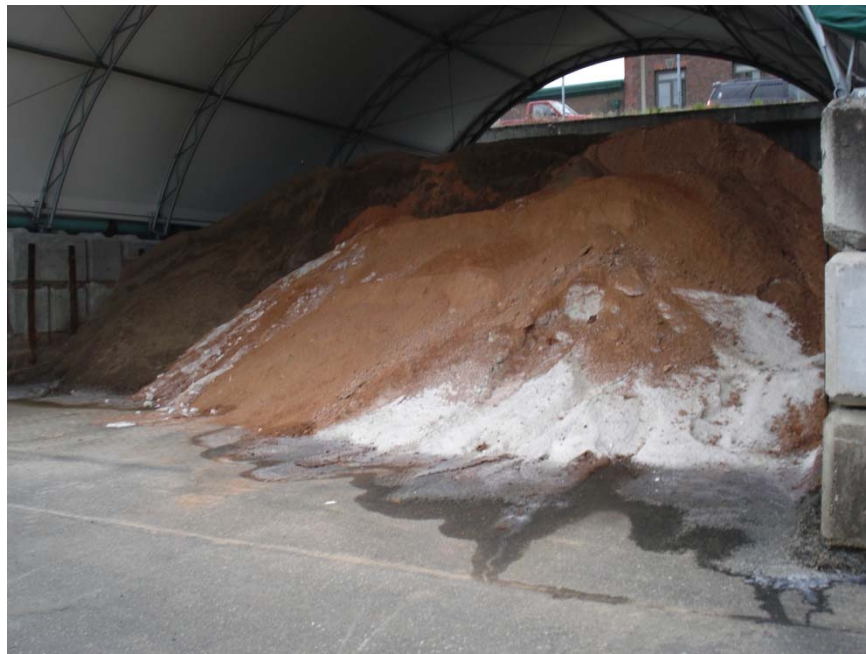
Photograph 26. Upper Yard Storage Garage – View of run-on water seeping through the bottom of salt/sand stockpile.

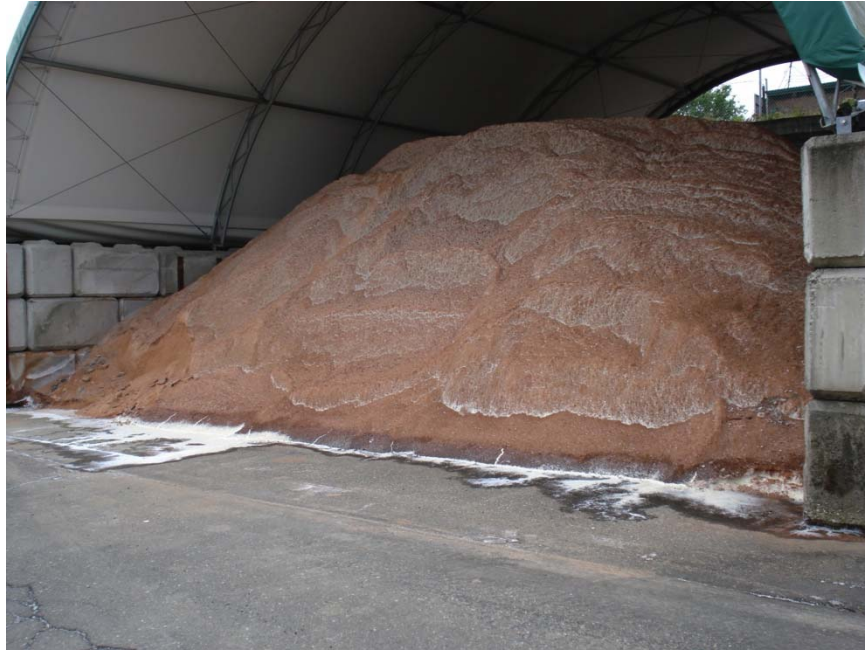
Photograph 27. Upper Yard Storage Garage – View of run-on water seeping through the bottom of salt stockpile causing salt migration.

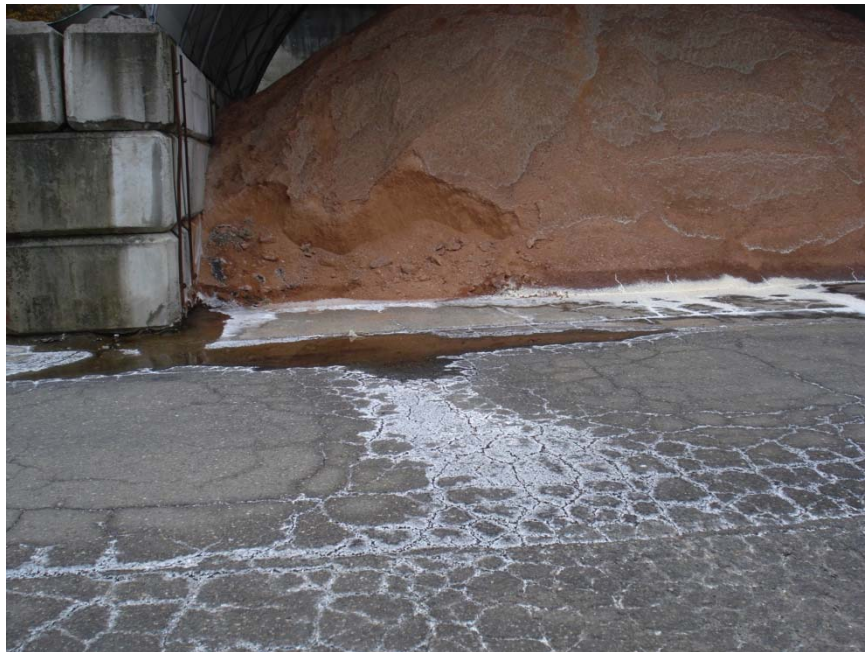
Photograph 28. Upper Yard Storage Garage – View of salt in the cracks of the asphalt pavement downgradient of the salt stockpile. Note the water seeping under the stockpile and the concrete barrier.
